# NEW ZEALAND AGRICULTURAL AVIATION

## SAFETY UPDATE

MARCH 2019

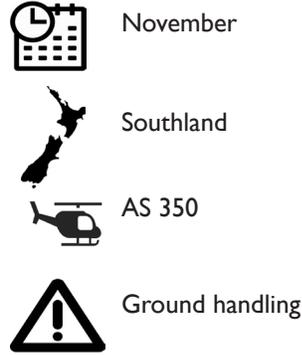
The operator reported that towards the end of a long day of spraying the loader driver connected the filler hose and then briefly discussed the performance of the spray gear with the pilot. After this they walked back to the mixing tank. Despite working all day with the policy of receiving a visual thumbs up signal before takeoff, the pilot lifted into the hover with the filler hose still attached. The loader driver was able to signal the situation to the pilot before they transitioned into forward flight.
