NZ Agricultural Aviation Update – June 2020

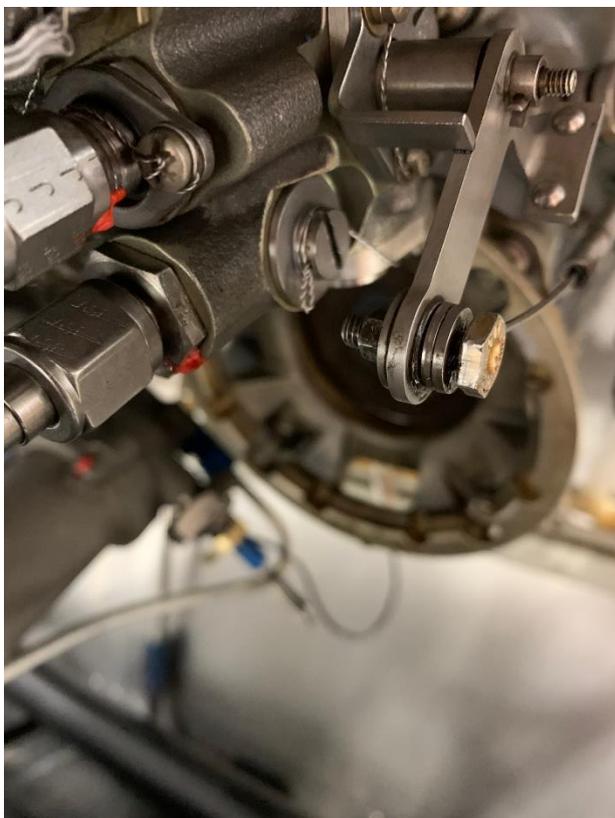
Engine FCU fuel cut off and throttle found at 100hr//12m Airframe inspection to be rigged incorrectly resulting in the control cables having next to no protrusion through the control bolts. This is caused by not following the correct procedure when installing the FCU/Engine which was installed at airframe TSN: 1603.80 on the 04/12/2019. There was also no compass swing carried out post engine installation IAW NZCAA AC43-7 Part 1. Engine FCU fuel cut off and throttle re-rigged IAW Robinson R66 M/M section 76 to have correct cable protrusion IAW Figure 76-3.

Compass Swing carried out IAW NZCAA AC43-7 part 1 using Tooling RST-76 Due calibration 30-Aug-20 calibration card fitted to helicopter.
