NEW ZEALAND

AGRICULTURAL AVIATION SAFETY UPDATE

JUNE 2019

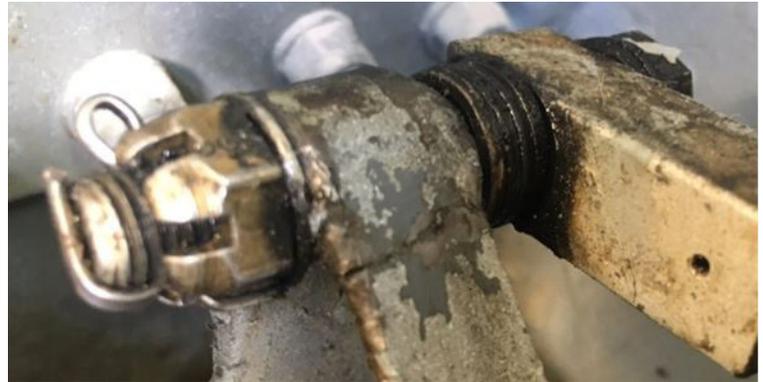
Flap torque tube

While on a refuelling stop the pilot noticed a cracked flap torque tube end that appeared very close to parting off. The crack extended almost the entire width of one side of the lug – see image below. The aircraft underwent a check servicing so the torque tube was removed and paint stripped. A visual inspection of the entire torque tube was been carried out with nil defects detected. The torque tube was repainted white to aid in visual inspection/defect detection for the future.
