**NEW ZEALAND HELICOPTER SECTOR  
SAFETY UPDATE  
MARCH 2019**

# INTRODUCTION

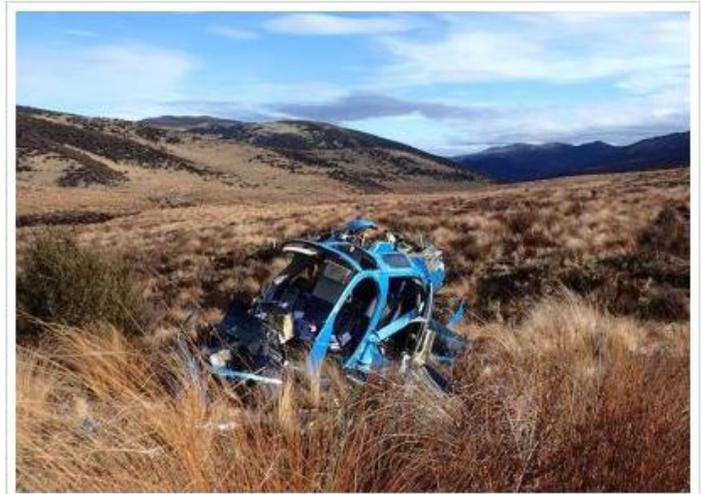
The helicopter crashed while on a survey operation, with one of the occupants dying in hospital after the accident. TAIC are investigating the accident.

The crash scene
