NEW ZEALAND HELICOPTER

SAFETY UPDATE

JUNE 2019

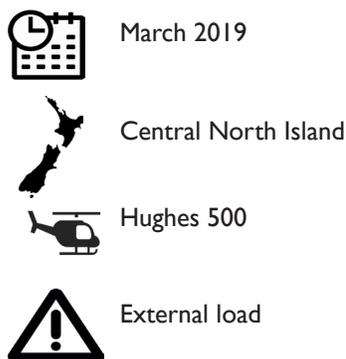
On the last load sowing seed while the pilot was following the fence line, he did not allow enough height to clear some poplar trees, and the bucket collided with the top of one of the trees. The helicopter was landing back at the loading site from an inspection of the bucket. Apart from a few twigs around the bottom of the bucket, there was no damage sustained.

The operator's investigation determined that a key cause of the incident was pilot distraction. There had been a sequence of events preceding the event which led to this, including the helicopter being returned from maintenance with a hot mic being constantly active, and the pilot's headset jack failing (leading to no comms with ground crew).

Furthermore there had also been some minor bucket issues on the previous job, and there was not enough product to complete the job the pilot was working on.

The farm manager had advised the pilot to go ahead with the product provided. The manager also called not long

after to advise the pilot to change the spreading rate to allow the product to cover the area required. During this time the light bar in the helicopter failed resulting in the pilot not being able to see what lines he had previously taken. These factors set the conditions for the distraction and loss of situational awareness that led to the incident.

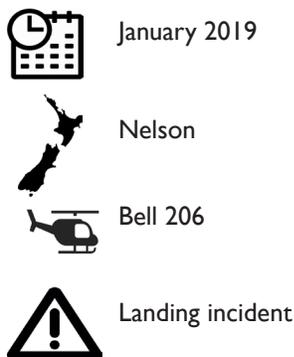
The pilot was carrying out a power-on landing at a remote site to unload 4 DoC workers. The 4 crew were out of the machine and were unloading gear from the luggage compartment when, due to the change of weight and CoG, one skid slipped off an unseen rock. This required the pilot to execute a quick lift off to stabilise the helicopter, before resettling the aircraft so the crew could continue unloading. The operator's report noted that incidents of this type were an important consideration when carrying out drop offs and pick ups at remote landing sites.

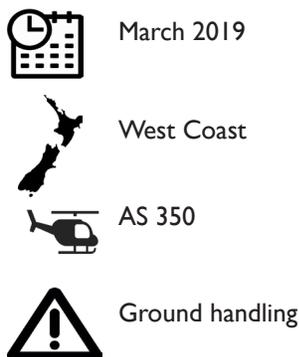
During refuelling, with the engine running and the flight controls unattended, a dog owned by one of the team

members jumped inside the helicopter and landed on the fuel control lever pushing it to flight idle. The sudden noise change alerted the staff member conducting the refuel (a commercial pilot) who entered the cabin and moved the fuel control lever back to ground idle.

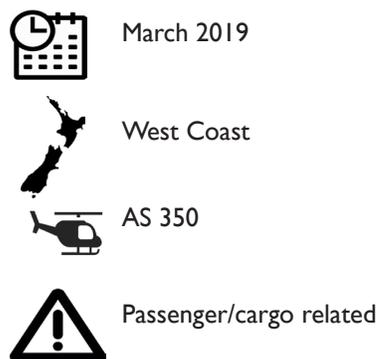
This incident involved a passenger unlatching the collective lever while the aircraft was at ground idle. The pilot had vacated the pilot seat to attend to the LHS short aft door opening. The collective lock was secure with collective friction on. The first PAX was loaded into the front seat as was two other PAX into the rear seats. A second PAX was then loaded into the second front seat, at which time the PIC believes the first front seat PAX assumed that only one person would be in the front dual place seat so attempted to move across into the pilot seat. It is likely the first person's seatbelt was not yet done up. When the pilot saw this happening, he immediately ran around to the pilot seat. While the passenger was attempting to move across she used the collective as a handle causing the collective lock to release. The pilot was able to get to the collective/controls before she moved back to her seat ensuring the situation was brought to an end.

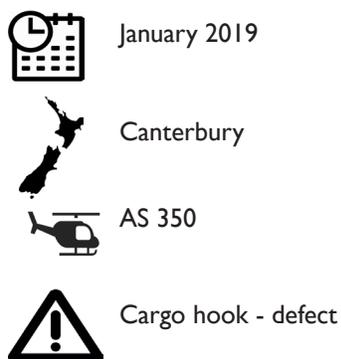
During agricultural fertiliser operations the pilot took off on the final load, with a bucket carrying 500kg of urea. As the pilot went through translation, approximately 20 - 30 feet agl, an upwards surge was felt, with a subsequent loud bang and tug down on the collective. The pilot took the pressure off the collective, looked in the mirror and saw that the bucket was no longer attached, with the hook dangling on its own cable. The pilot returned to land, keeping the hook in view at all times using the mirror. On shut down the pilot also found a 40cm rip in the belly cover caused by the hook cable being pulled during the incident. Upon further investigation it was found that the cargo hook universal joint had failed. Corrosion and fatigue cracking originating from around the bush on one side of the joint assembly has caused one side of the joint assembly to fail. The other side failed under the increased load. The maintenance provider has replaced the universal joint assembly and a 12 month NDT inspection has been implemented.
