**NEW ZEALAND HELICOPTER AND AGRICULTURAL  
AVIATION  
SAFETY UPDATE  
DECEMBER 2018**

# INTRODUCTION

This is a further update on activity and safety performance in the helicopter and agricultural aviation sectors, with activity and accident rate information current to September 2018. The report includes details of accidents and serious incidents for the purpose of raising awareness about risks and sharing lessons amongst the sector.

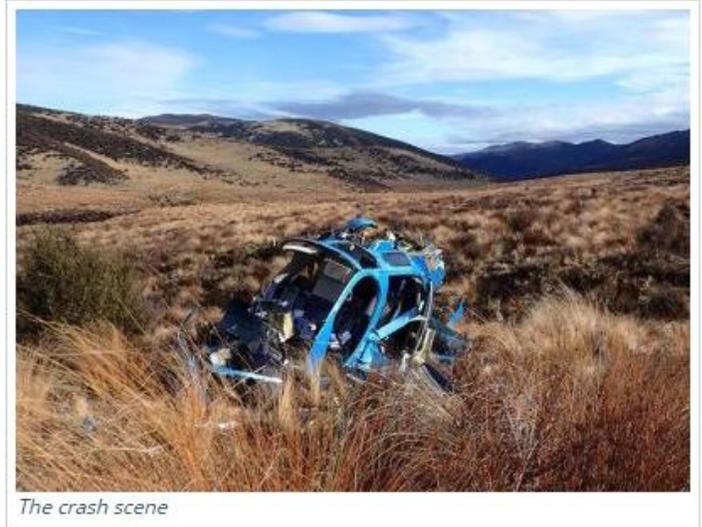
The helicopter crashed while on a survey operation, with one of the occupants dying in hospital after the accident. TAIC are investigating the accident.

The crash scene

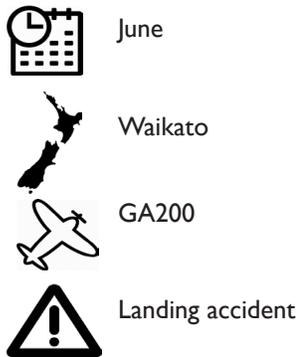
After touchdown, directional control was lost. The aircraft ground looped and incurred some rear damage when coming to rest down a slope on the edge of the airstrip after veering to the left. The investigation determined that the tail wheel spring securing bracket bolts had failed causing the rear spring to lose directional control of the aircraft, with the situation exacerbated by the slippery surface of the airstrip caused by dew.

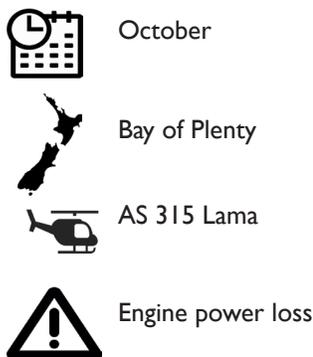
During a forest spraying operation, taking the weight while lifting with another load, at approximately 40ft there was a load bang from the engine, immediately followed by a loss of power. The pilot used the remaining rotor energy to reduce the rate of descent but landed heavily in the upright position. There were no injuries but the aircraft sustained some damage.

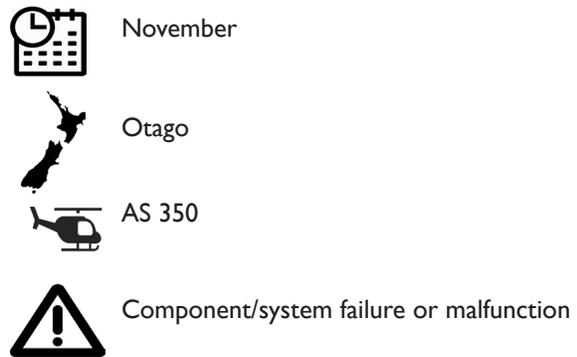
Forced landing accident. While on approach to conduct a spray run, the engine failed at approximately 60 feet AGL. The pilot manoeuvred the aircraft to land on a nearby track during the autorotation. Upon impact the tail boom failed and one of the skids bent. There was damage to helicopter but nil injuries. The engine had suffered an internal failure causing the turbine assembly to move rearwards severing the Py sense line and shutting down the engine.

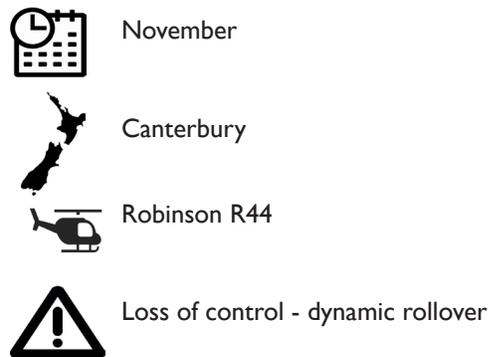
The helicopter was spraying a field, and when the pilot made a reversal turn to fly out the low RRPM warning horn sounded. The pilot dumped the load and decided to make a run-on landing directly ahead. During this the skid dug into the ground and the helicopter rolled over. There were no injuries but the helicopter sustained some damage.
