**NEW ZEALAND AGRICULTURAL AVIATION
SAFETY UPDATE
2016**

INTRODUCTION

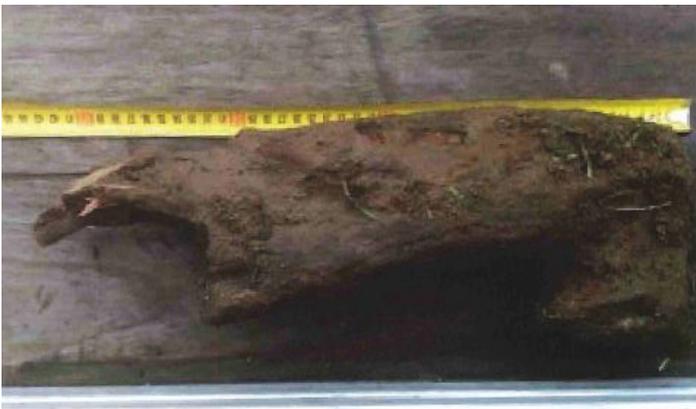
During the take off the aircraft ran over a loose piece of wood, which flicked up into the LH brake hydraulic line, leading to total brake failure on that side. The pilot needed to apply full right brake to maintain directional control, as the aircraft yawed into the crosswind. There was a loss of ground speed and the pilot jettisoned the load near the end of the

strip, however this was not sufficient to take off and the aircraft touched down heavily on a paddock ahead before getting airborne. After making several passes over ground crew to inspect the undercarriage damage, the pilot successfully flew to Taupo for an engineering inspection. This revealed that along with the damaged LH brake line, there was damage to one main undercarriage leg and the tailwheel assembly that required replacement.

On a subsequent inspection carried out as part of the investigation, further pieces of wood were identified laying amongst the grass around a centre section of the strip. The site itself was on an ex-forestry block that had been converted to a dairy farm over

the preceding 19 months. Evidently the sections of wooden debris had been buried for some time but had worked their way to the surface. Prior to commencing the job the farm manager had inspected the strip on his bike to check its condition. The pilot was familiar with the strip, having conducted 15 separate jobs on it from when the forestry block was first converted to farmland.

Image of wooden debris from the airstrip

The operator undertook to update procedures for working on substandard airstrips, such as those on “Forest-to-Farm” land, by requiring crew to walk the airstrip themselves and remove any debris prior to, and during, operations on it.

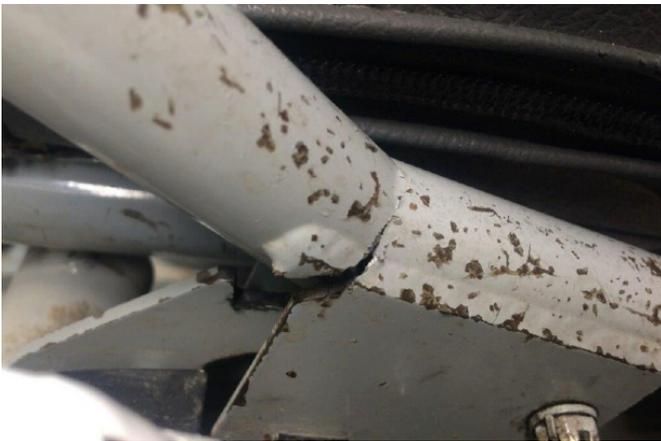
The flap handle cracked due to fatigue. The crack had initiated from the front of the slot in the lower rear section of the flap handle. The handle was removed and replaced. An image of the cracked handle is included below.

Image of the cracked handle

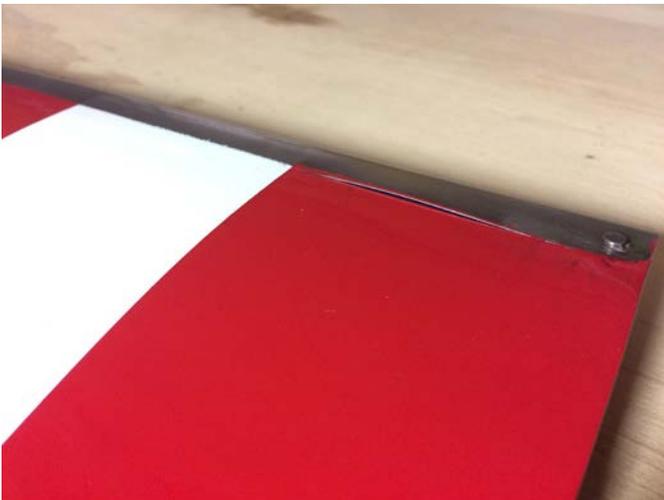
While the pilot was carrying out a pre-flight inspection of the helicopter they identified that the leading edge of the newly installed tail rotor blade was delaminating. The cause of the delamination was failure of the adhesive used to attach the leading edge. The blade was replaced and the helicopter was returned to service. Image included below:

Image of the delamination of the leading edge
