# Agricultural Aviation Safety and Activity Update

March 2016

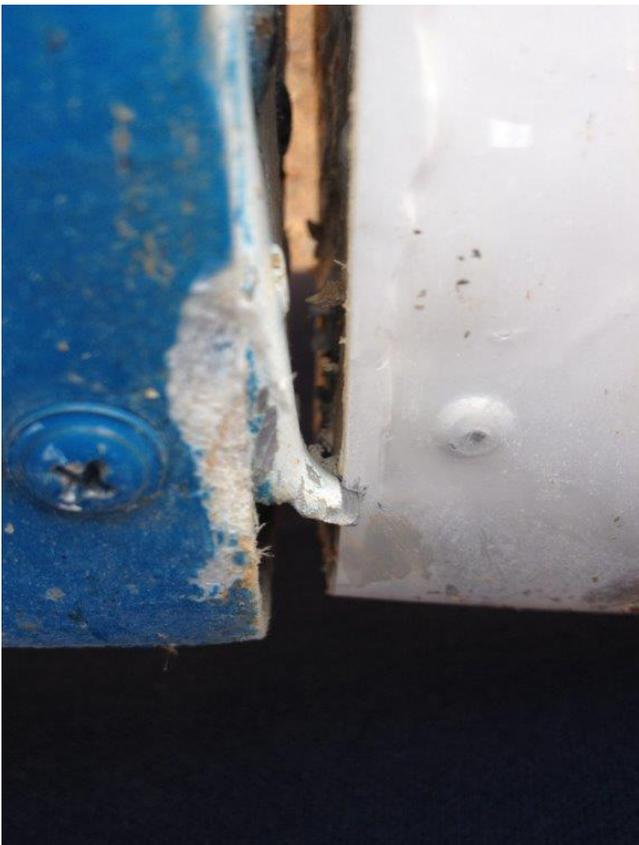
Cresco elevator jammed solid moments after landing on a newly-metalled airstrip. On inspection an aluminium tab was found stuck in the plastic protector on the leading edge of the stabiliser (image below). The strip had been metalled and rolled but had loosened-up over the course of the job, causing then damage.
