NZ Helicopter Sector Activity and Safety Update

October 2016

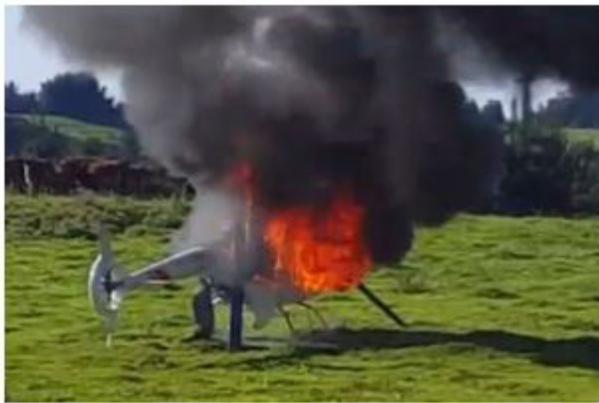
The pilot and sole occupant of helicopter heard some noise and smelt smoke after departing from Rotorua Aerodrome. He made a precautionary powered landing on a farm paddock nearby. When he saw flames coming from the engine area, he shut down the helicopter and moved away. The helicopter was destroyed by fire before the fire service could respond. An investigation into the accident is underway.

Image 1: The helicopter on fire after landing.

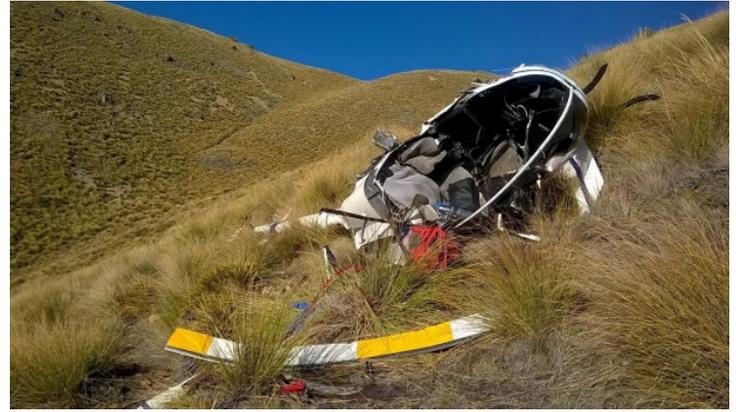
The helicopter was on a private flight with the pilot and a passenger on board. It impacted terrain in the Lindis Pass area. The passenger was killed and the pilot sustained serious injuries. The investigation into the accident is ongoing.

Image 2: The R22 wreckage and accident site.

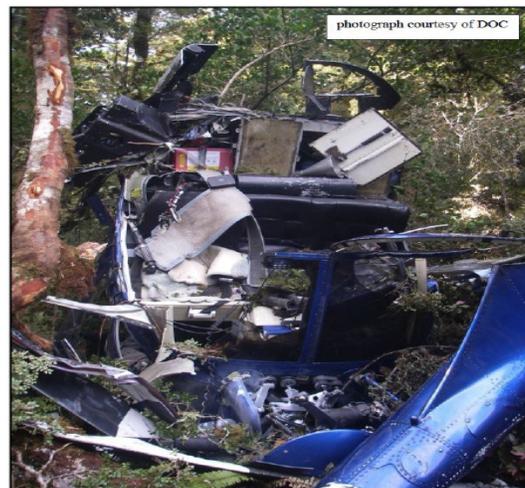
The helicopter was about to land at a hut to drop the passengers when it encountered a slight tail wind that resulted in the helicopter spinning around and settling into some trees before dropping to the ground. The TAIC investigation found the pilot had been complacent in regard to the following aspects of flight preparation:

- not being fully involved with the loading of the helicopter, which meant he did not assess the accuracy of the cargo weight
- not ensuring that the shoulder harnesses were accessible and worn by the occupants
- not determining that the passengers were familiar with the safety briefing.

The investigation determined that the helicopter's engine and flight controls were operating normally, and found no evidence that a technical malfunction contributed to the accident. The helicopter was heavily loaded, but not overweight, and the flight manual charts showed that it had the performance capability to hover out of ground effect at that altitude. The investigation determined that the un-commanded yaw and loss of control resulted from the approach being attempted under conditions that were noted in the flight manual to be conducive to a loss of tail rotor effectiveness. The precipitating factors for a loss of tail rotor effectiveness can occur singly or in combination, and several were present. The most significant were the weathercock stability and the loss of translational lift during a downwind approach, and the high power demand as the helicopter came to a hover. The full accident report is available [here](#).

image 3: The 500 wreckage

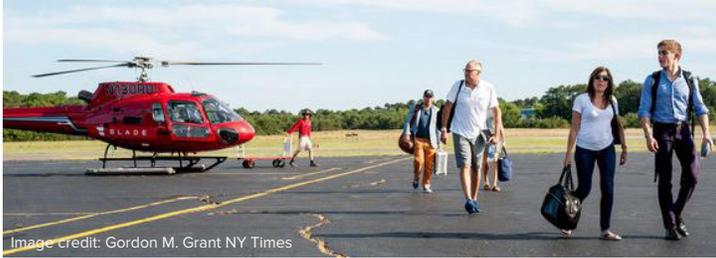
In this incident, the helicopter’s passengers failed to comply with their pre-flight briefing. 3 of the 6 passengers moved and stood behind the helicopter to pose for photographs. Passengers had been briefed prior to flight and again prior to landing. The operator’s report stated *“Fortunately the MD600N is a NOTAR helicopter otherwise this could have had very serious consequences”*. The operator undertook to translate their passenger safety cards into Mandarin.
