**NEW ZEALAND HELICOPTER  
SAFETY UPDATE  
SEPTEMBER 2018**

# INTRODUCTION

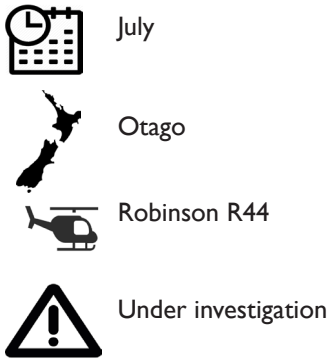
The aircraft went missing in the vicinity of Stevenson’s Island, Lake Wanaka. A TAIC investigation into the accident is underway.

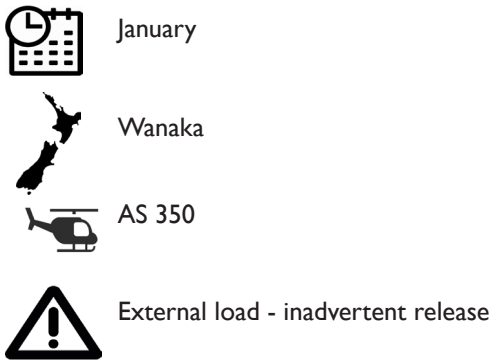
During fire fighting operations, as the aircraft approached the fire line for a water drop, the pilot repositioned his hand on the cyclic grip in preparation and inadvertently electrically released the cargo hook, and the fire bucket was dropped.

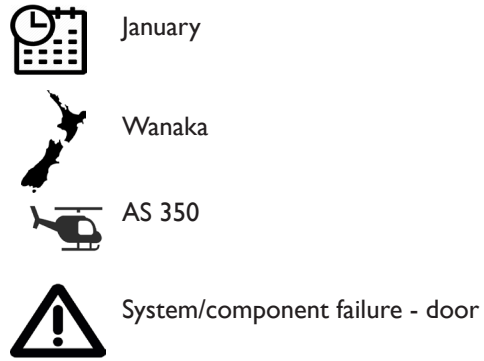
During external load operations, removing beehives, the right hand sliding door came off and was lost in flight. The pilot noticed the door light illuminated on the third run. After two more runs, with the light still illuminated, pilot looked over his shoulder and realised that the door was gone. Initial inspection of the door and with reference to CAN 05-008, it appears that at least 2 elements of the right hand sliding door installation (SB52-00-14) was not carried out when aircraft was modified in 2014.

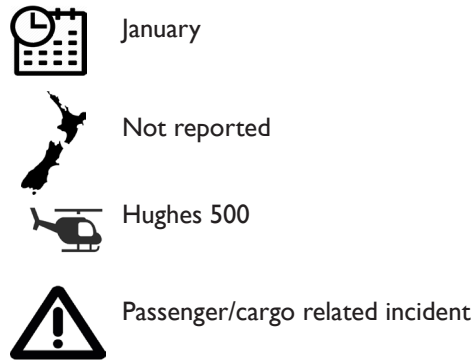
While conducting bee hive placements the two front doors of the aircraft were removed. As planned, the pilot landed to pick up two beekeepers to relocate them to another site. While in the cruise between the two sites one of the beekeepers removed a mobile phone from a pocket to take a photograph. The phone dropped from the helicopter.

When the pilot landed and shut down marks were noticed on the tail rotor blades, consistent with a strike

from the mobile phone. A small mark on the leading edge of the vertical stabilizer was also visible. The helicopter was inspected and the tail rotor blades removed from service.

In future, the pilot will ensure that all persons on board the aircraft, while doors are removed or windows open, are reminded that all mobile phones are to be stowed or sufficiently secured before flight.

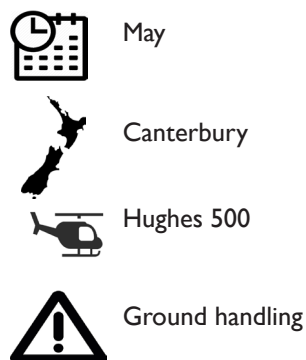
After an aerial wand spraying operation, with the helicopter at ground idle, as crew removed the spray gear the loader driver inadvertently lifted the spray wand into the rotating main rotor blades. The helicopter was immediately shut down. One main rotor blade was found damaged and a replacement blade was fitted.

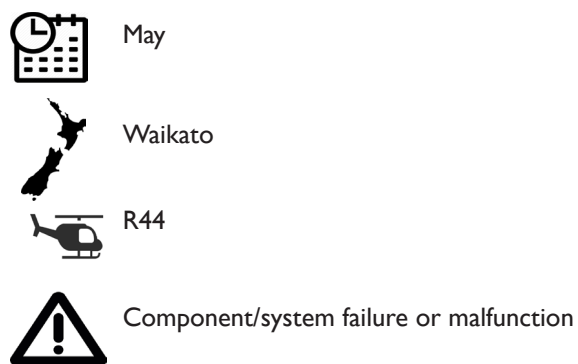
During the approach to land the helicopter lost some power and the engine started vibrating. The investigation revealed that number 4 cylinder exhaust valve had stuck and caused the push rod tube to bend. The cylinders had recently been top overhauled 100-200 hours prior.
