NZHA Helicopter Safety Initiative – Notice 1 – Treating the Biggest Cause of NZ Helicopter Accidents

Loss of Control – Performance Management (LOC – PM)

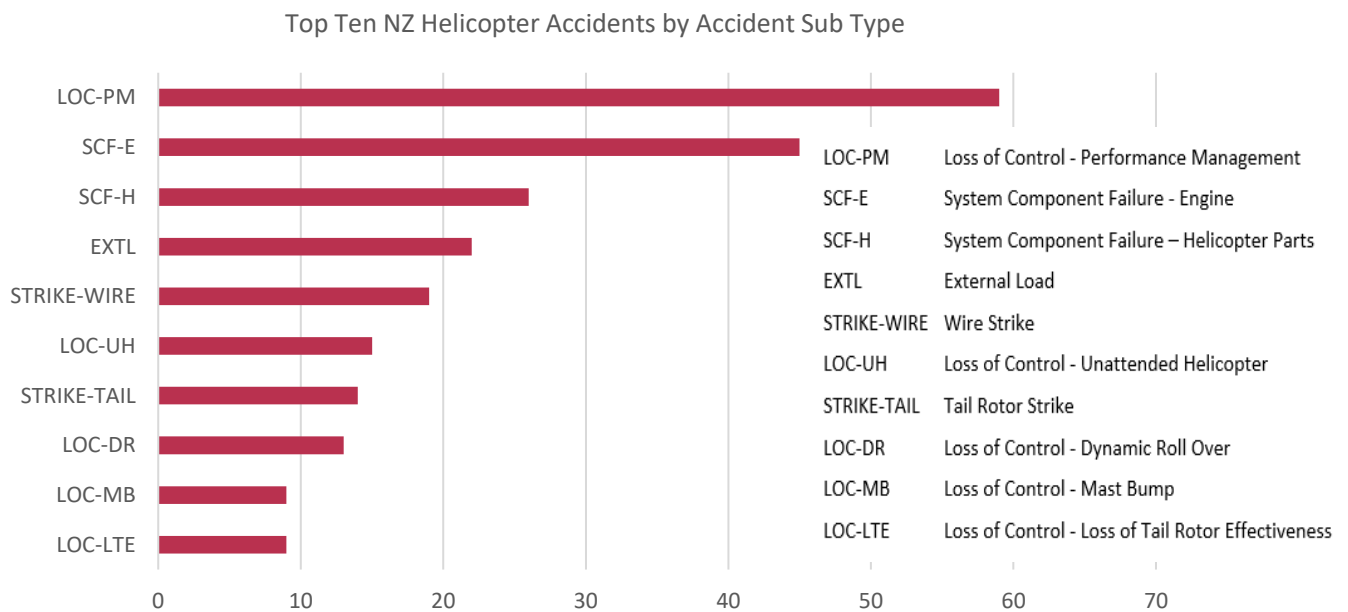
A NZHA/CAA analysis of all New Zealand helicopter accidents between 2000 and 2019 has shown that the most commonly-occurring helicopter accident is Loss of Control due to poor Performance Management (LOC-PM). This aligns with International Helicopter Safety Foundation ([IHSF](#)) data. (*Decode shown in right hand side of first graph below*)

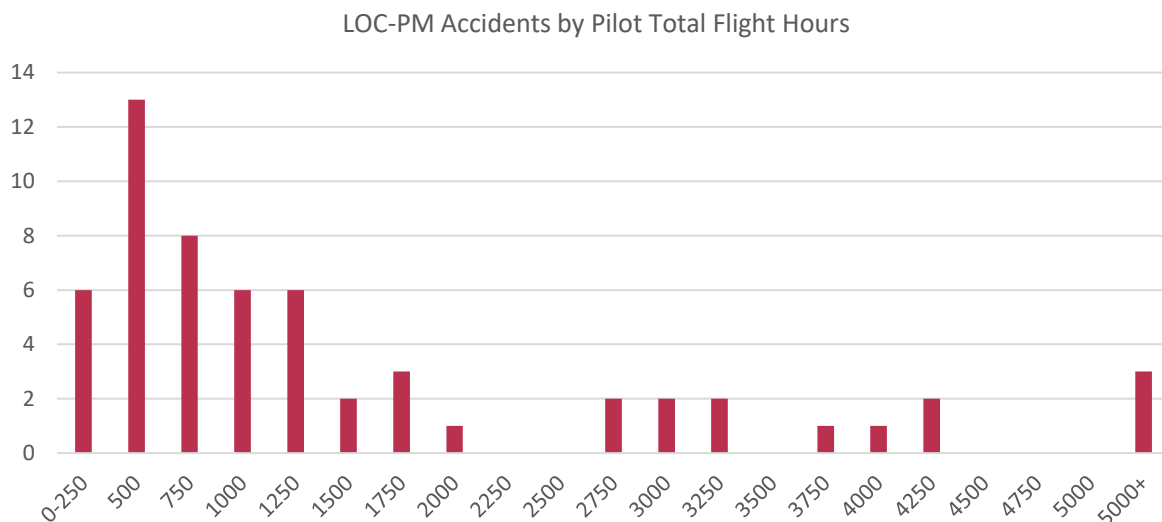
Yes. The 'experience factor' is evident when we look at the number of accidents by pilot total time. Experienced pilots (>5000 hours) have these types of accidents too but you are at greater risk if you have:

- less than 250 hours on type or
- less than 1500 hours total time

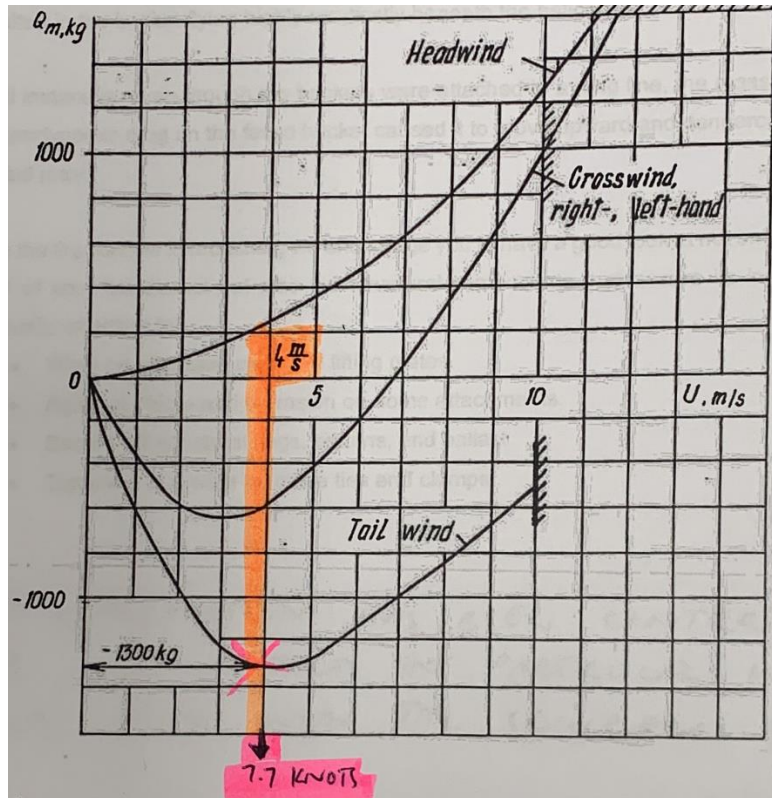
Mi-8MTV-1 Performance Graph – Weight vs Wind Velocity and Direction with use of ground effect.

This Mi-8MTV-1 graph highlights a 10% performance degradation with 7.7 knots of tail wind (MAUW 13,000kg). If you have the wind wrong the degradation in performance can be catastrophic.
