# NEW ZEALAND AGRICULTURAL AVIATION

## SAFETY UPDATE

SEPTEMBER 2018

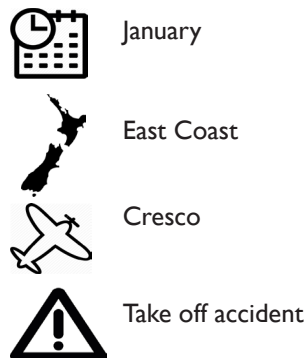
The aircraft encountered sink on take-off just after getting airborne in light south east wind and hot humid conditions at 1200'ASL. This caused the tail-plane and elevator to strike a fence post at the airstrip threshold.

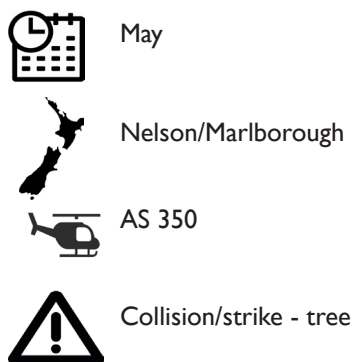
On an operation spraying a forestry block, during a turn coming back to start another spray line the helicopter struck a tree with the main rotor blade. The strike damaged one of the blades significantly and put the aircraft out of balance. The pilot landed the helicopter on an old forestry skid site a 100m away. Cloud cover and poor light were identified as key causal factors for the pilot not identifying the tree.

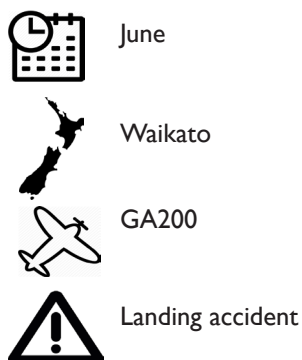
After touchdown, directional control was lost. The aircraft ground looped and incurred some rear damage when coming to rest down a slope on the edge of the airstrip after veering to the left. The investigation determined that the tail wheel spring securing bracket bolts had failed causing the rear spring to lose directional control of the aircraft, with the situation exacerbated by the slippery surface of the airstrip caused by dew.

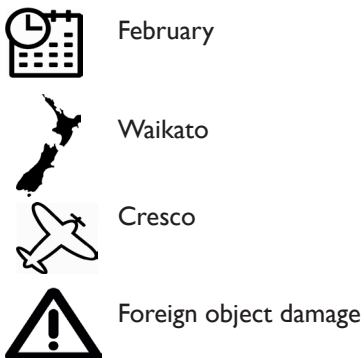
During take-off, stones thrown from the main wheels impacted the elevator tip fairing which is fibreglass, this deflected backwards deforming the filler plate in to the tailplane - jamming the two together. The pilot dumped the load and managed to return to the airstrip. This problem appeared 25 years ago on Crescos, but has resurfaced with XL tailplanes now being used in agricultural operations.

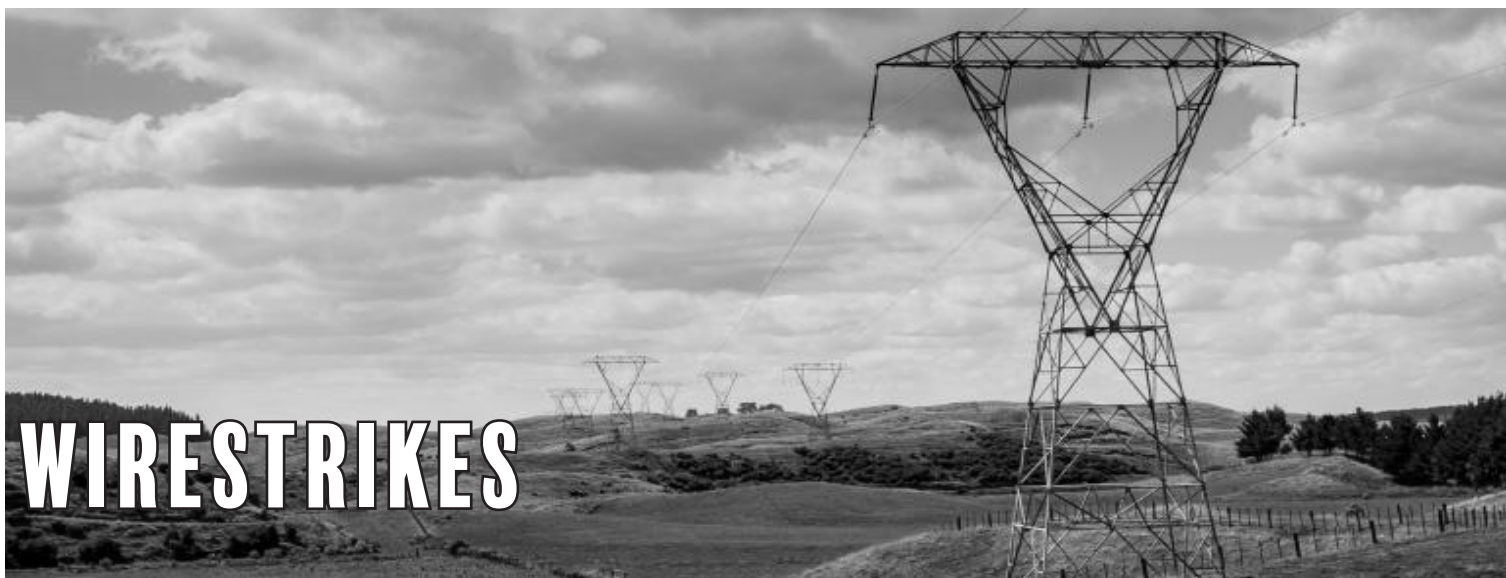
This was starkly demonstrated by the accident involving ZK-JPU, a PAL 750XL. ZK-JPU was observed following a fellow company aircraft and subsequently striking 6 High Power Conductors. The safety investigation is still ongoing, however the initial findings indicate that the pilot had just completed the first job of the day and was in transit to the next job. The pilot was familiar with the area and was likely aware of the hazard, however it was unlikely that the pilot took the time to review the specific hazards prior to entering the local area. **According to research conducted by the ATSB into aerial application occurrences, 63 % of the pilots knew where the wire was before striking it.**
